## FEASIBILITY STUDY

OLMSTED PARKS CONSERVANCY  
LODGE BUILDING ANALYSIS  
CHICKASAW PARK

## EXISTING CONDITIONS ANALYSIS

# FEASIBILITY STUDY FOR THE REVITALIZATION OF CHICKASAW'S LODGE

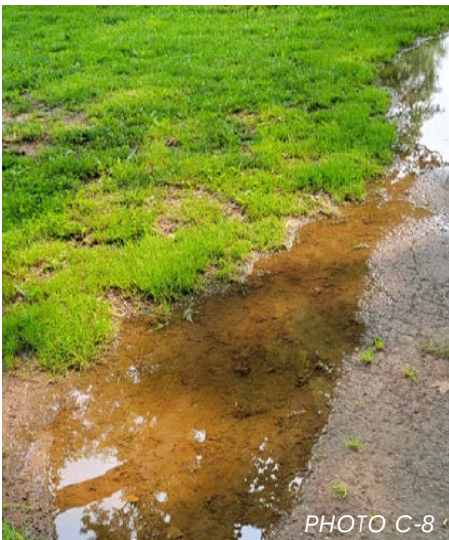
PHOTO C-8  
Pavement Edges

3. Edges of Pavement: Rainwater is caught in edges between pavement and lawn with no outlet, creating muddy edges when wet and bare patches of soil when dry.

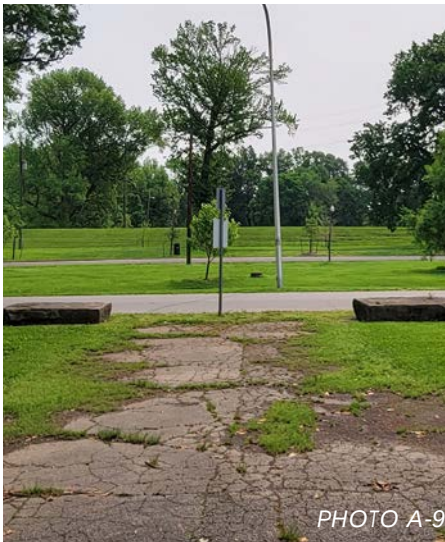
PHOTO A-9  
Front Entrance

1. Front entrance: The front walkway to the Lodge building is asphalt. There are numerous cracks, areas of ponding, and encroachment of grass into the asphalt.

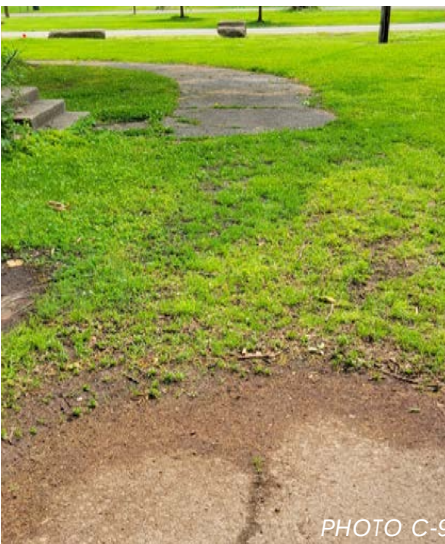
PHOTO C-9  
Missing Sections

3. Missing Sections: In some areas along the back and side of the building, entire sections of pavement are missing or covered with soil and vegetation.

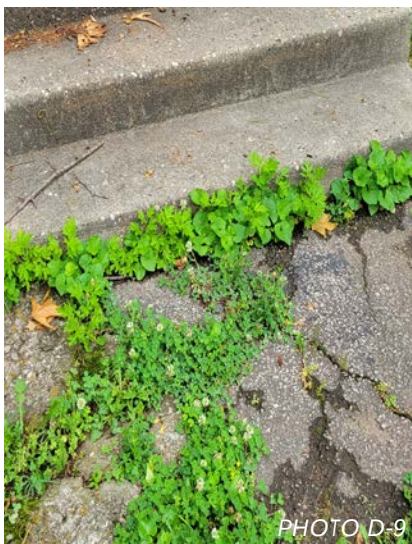
PHOTO D-9  
Steps

4. Steps: Cracked pavement is creating uneven and dangerous conditions at landings for steps.

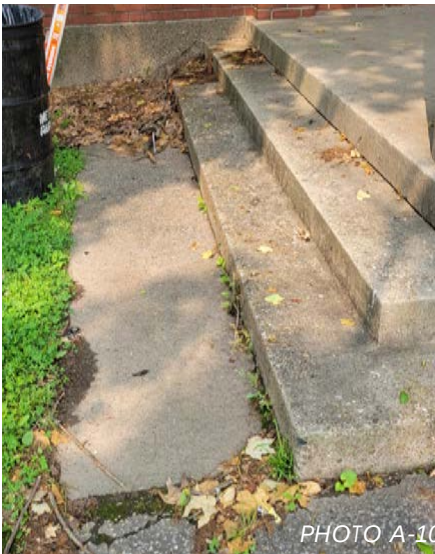
PHOTO A-10  
Front Steps, left side

1. Left side of steps have a narrow concrete band at the bottom. Asphalt is cracked and uneven. The condition of steps is fair with some unevenness on the edges.

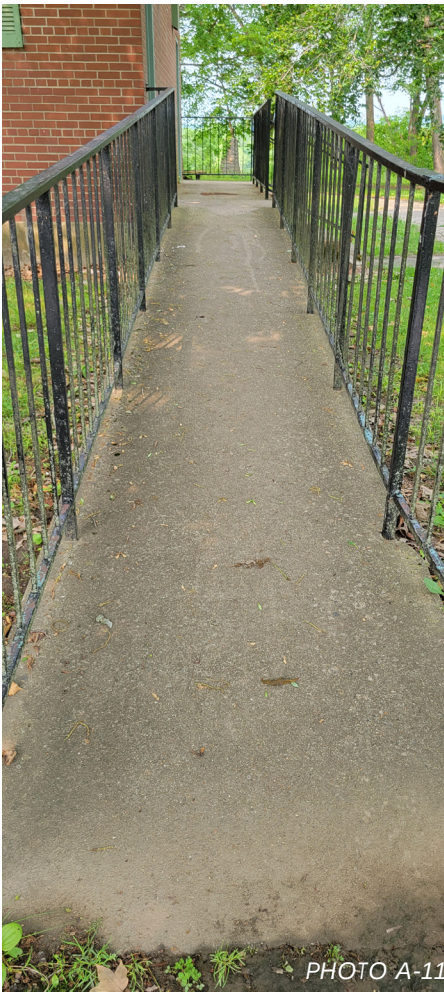
PHOTO A-11  
Restroom Ramp

1. The concrete ramp leading to the restrooms does not show signs of cracking or spalling on the surface. The ramp is too narrow; it does not provide the minimum clearance between rails and the railing does not meet current code for design. The railing is in poor condition with a number of bent pieces.

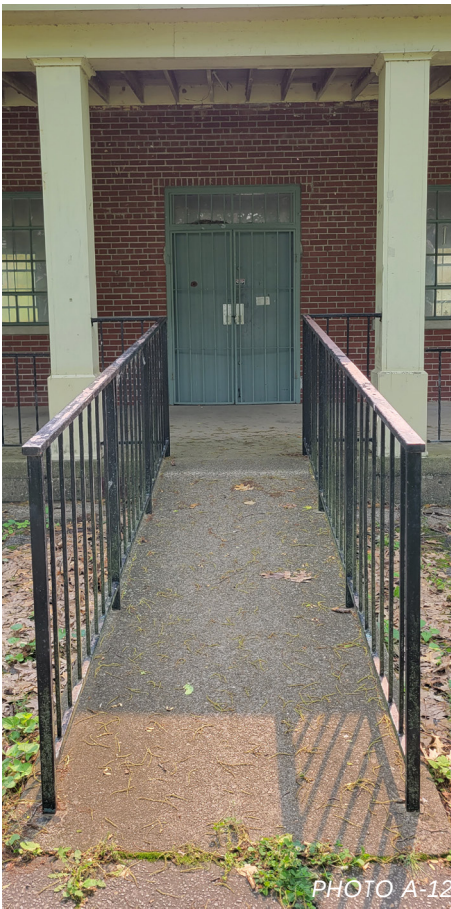
PHOTO A-12  
Back porch ramp

1. The concrete ramp leading to the back porch is in reasonably good condition but does show signs of age with discoloration and staining. The ramp is also too narrow; it does not provide the minimum clearance between rails and the railing does not meet current code for design.

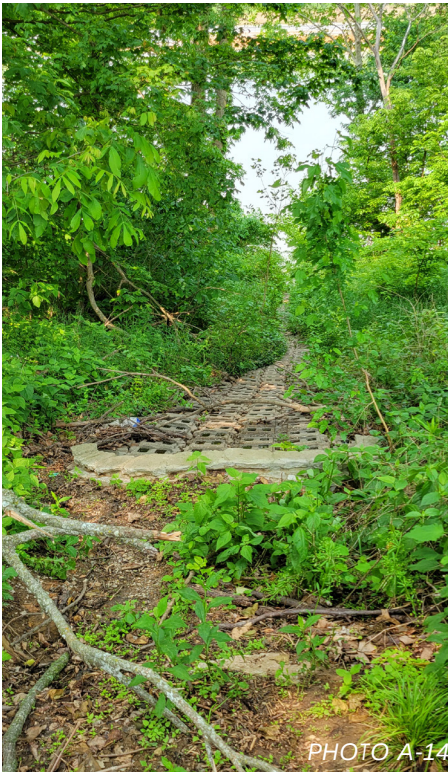
PHOTO A-14  
Storm outfall to Ohio River

1. The stormwater system in the area is collected in pipes and daylights at an outfall on the Ohio River bank.
2. A path connects the back yard of the Lodge Building to the old Concession Building, which now functions as a shade shelter.
3. The backyard of the Lodge Building overlooks the Ohio River. Some clearing of vegetation has been completed, creating some limited views to the river. An old stone fire place is located on the edge.

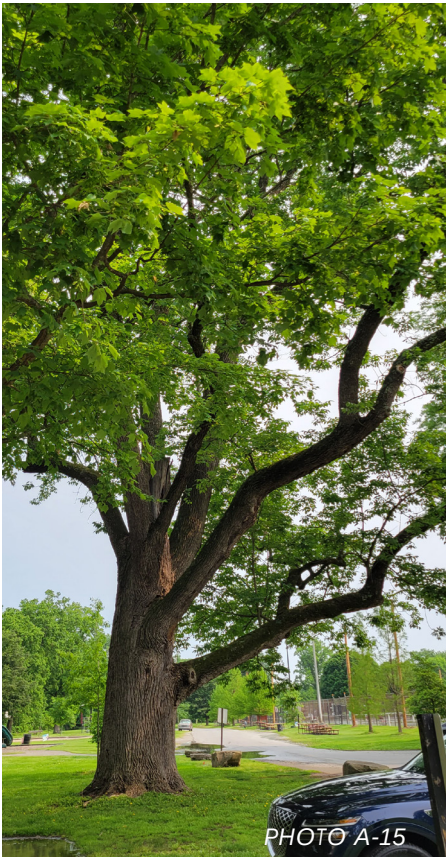
PHOTO A-15  
Large Ash Tree

1. The large ash tree appears as far back in the plans as the 1950s. The tree appears to be receiving treatment for EAB and is in good health. Other tree species present include, but are not limited to, Maples, Tulip Poplars, and Oaks.

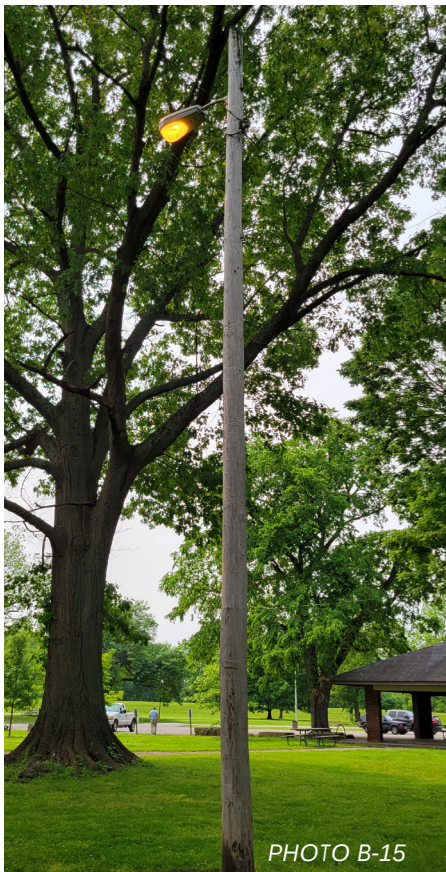
PHOTO B-15  
Utility pole (back of property)

2. A standard utility pole with a cobra head light attached is located in rear of the building.

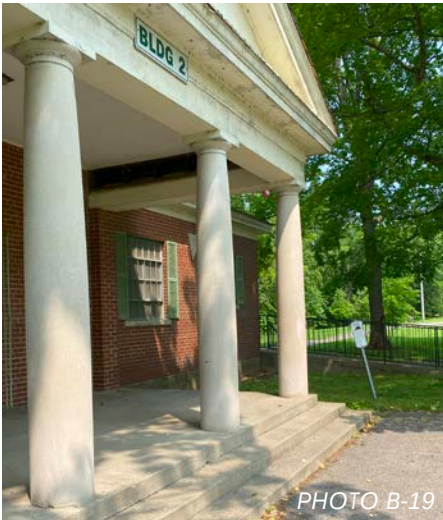
*Concrete Columns  
Note missing frieze board*

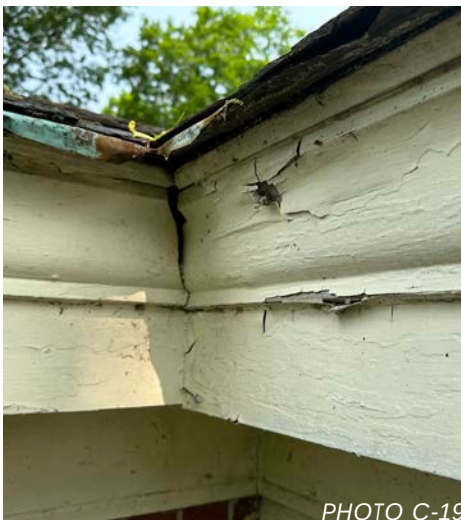
*Typical Gutter/Frieze Board Detail.  
This Photo showing typical paint  
deterioration.*

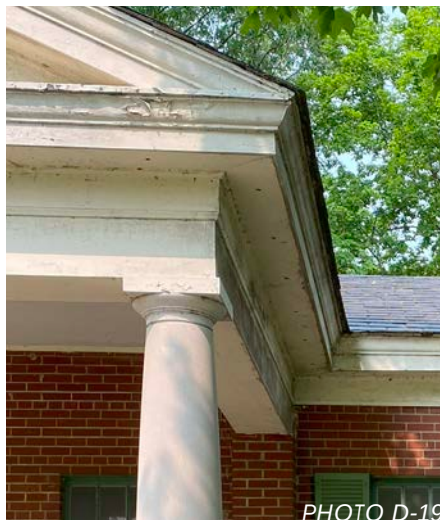
In reviewing the original design drawings, the original wood Doric style wood columns have been replaced with concrete/plaster columns. Based upon our review, these columns appear to be in good condition. The abacus (top of the capitol) has been painted at some point. Several of these abacus' are showing signs of the paint failing.

*Column Capitol Detail Photo.  
This Photo showing typical paint  
deterioration.*

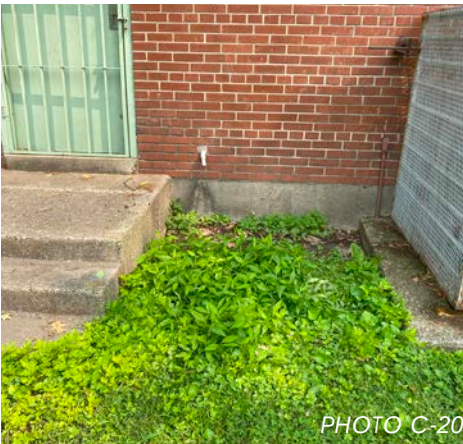
PHOTO C-20  
Detail photo of grade around  
the air conditioning unit.

It should be noted that on this side of the building, the grade slopes toward the building between the two access doors where the air conditioning unit is. This grading should be reworked to slope away from the building and provide positive drainage in this areas. Also refer to the civil section of this review.

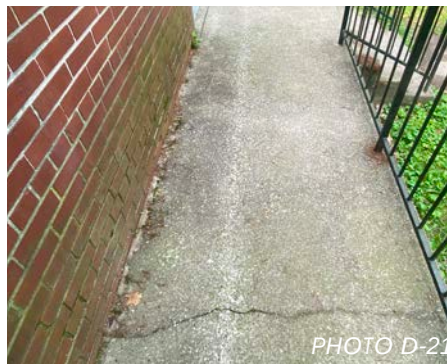
Photo of crack in concrete stoop.

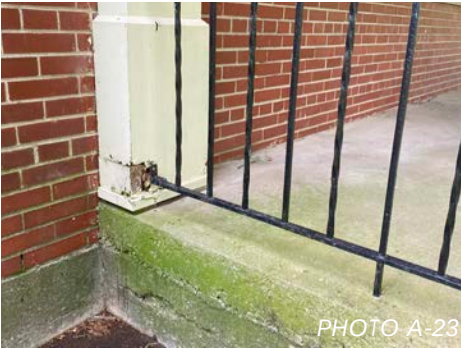
PHOTO A-23  
West Porch Column  
and railing

At the time of the 1988 renovation, the original wood roof supporting columns were removed and new hollow wood columns were constructed. In reviewing the new wood columns, most or all of these columns are showing various degrees of wood rot. This also includes the wood columns that are engaged with the exterior wall. Upon closer inspection of the construction of the wood columns, we discovered several details that were overlooked when the columns were built. When designing/constructing exterior wood columns, it is necessary to provide a vent space at the top and bottom of the columns. This vent allows for moist air that develops within the column to escape and ventilate. The columns were not constructed with these vents thus contributing to the degradation of the columns. Additionally, since these columns were originally constructed as hollow load bearing columns, the wood joints of the column shafts were built using lock-mitered corners. The columns that are in place currently in place were not constructed using the same method.

The painted metal railings currently installed have limited connections to the wood columns and a single point of connection to the concrete floor. We suspect that if tested, these railings would not pass the horizontal safety loads required for today's building code.

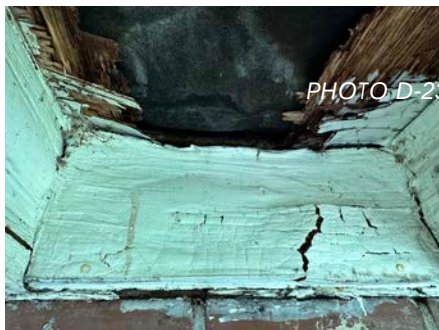
PHOTO D-23  
Damaged Frieze Board  
and Sheathing

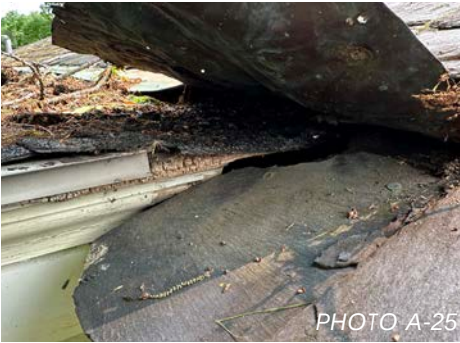
For the condition of the roof flashing, we noticed that in multiple locations, there was an attempt to make isolated repairs over the years. In some locations these repairs were successful but in many cases the repairs were not installed correctly. The most notable location is the transition between the pitched roof and the low sloped south porch roof. The current flashing installation is allowing water to get into the building as well as damaging the roof sheathing of both the pitched roof and the porch roof. In several locations along the porch roof transition line, the roof sheathing and the porch roof rafters have developed significant wood rot. This is almost to the point of isolated failure.

PHOTO A-25  
*Porch Roof Flashing Failure Detail*

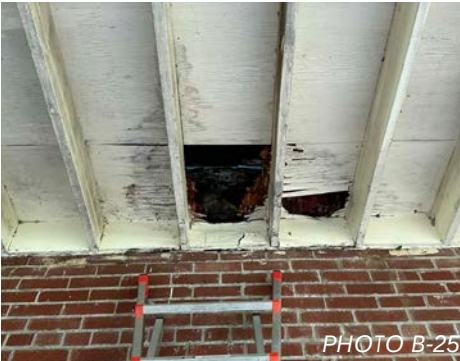
PHOTO B-25  
*Porch Sheathing and Framing Water Damage*

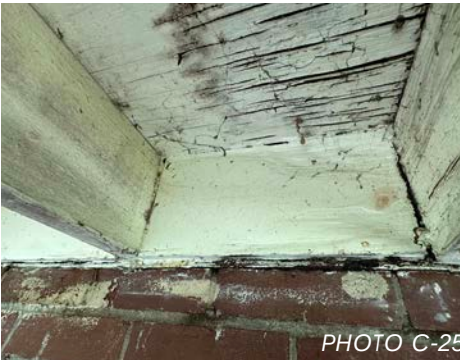
PHOTO C-25  
*Porch Sheathing and Framing Water Damage*

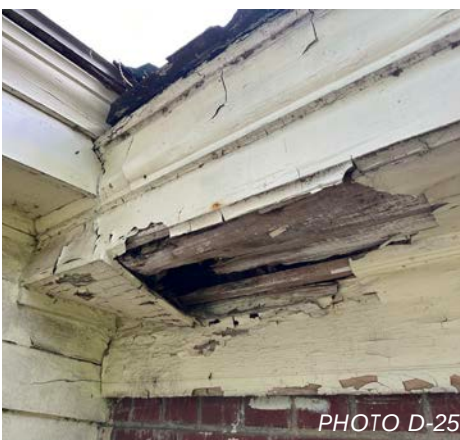
PHOTO D-25  
*Porch roof/Pitched Roof Cornice deterioration Photo*

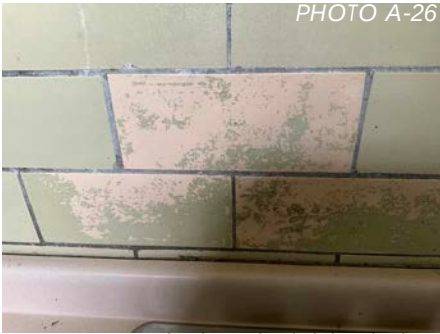
**Kitchen:** The kitchen walls use the same multi wythe wall system but with a glazed brick at the interior of the structure. Some of these glazed bricks are showing signs of wear and discoloration. The current appliances in the kitchen are a stove and refrigerator with a sink and countertop on the opposite wall. The ceiling has a missing light fixture and an additional light from 1988. The door that exits to the exterior swings in the wrong direction and has an additional security gate.

PHOTO A-26  
*Damaged Glazed Brick in Kitchen*

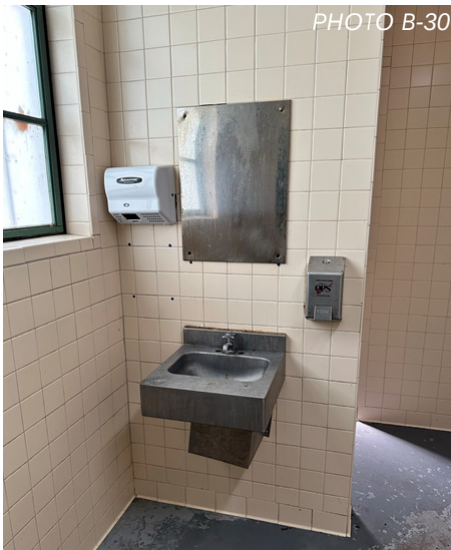
PHOTO B-30  
Bathroom Conditions

**Men's Bathroom:** The men's restrooms has floor to ceiling tile on the walls with a gyp ceiling. There is a ceiling hatch with access to the plumbing above. The current finishes in the bathroom are dated and past their lifespan. The ceiling in the bathroom is failing in multiple locations and the exposed metal vents/hatches are rusting, indicating moisture retention. The bathroom both serves the lodge and the park. According to the original drawings, similar to the kitchen, the interior walls are also glazed brick behind the current tile.

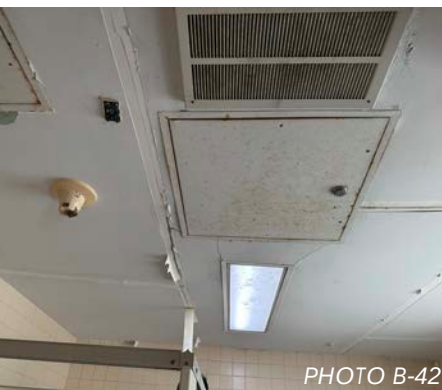
PHOTO B-42  
Men's Room Ceiling Damage
