## FEASIBILITY STUDY

OLMSTED PARKS CONSERVANCY  
LODGE BUILDING ANALYSIS  
CHICKASAW PARK

## EXISTING CONDITIONS ANALYSIS

# FEASIBILITY STUDY FOR THE REVITALIZATION OF CHICKASAW'S LODGE

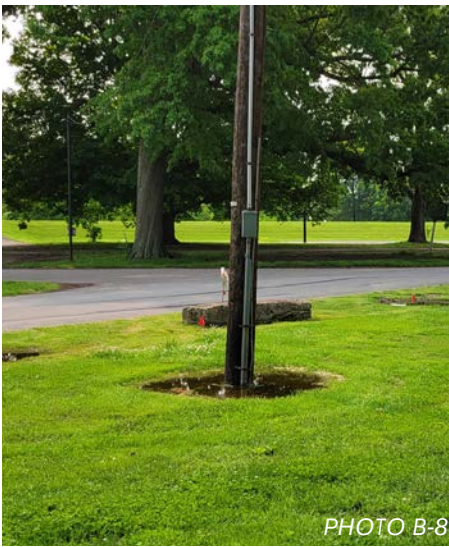
PHOTO B-8  
Ponding Water in Lawn

2. Ponding Water in Lawn: At various places throughout the lawn, small pools of water can be found. The photo at left shows ponding around a utility pole. Historical photos from 1952 show ponding as well, indicating a long term problem (see Grand Opening photo page 4).

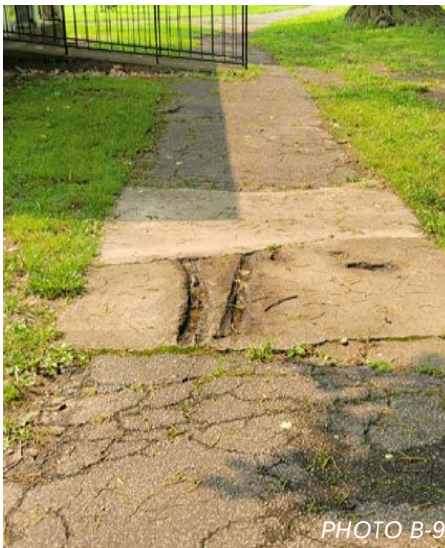
2. Back Walkway: The back walkways is a combination of asphalt and concrete. The concrete section is possibly a patch over a utility line, but that is unknown at this time. The pavement is uneven, cracking, and generally in need of repair.

PHOTO B-9  
Back Walkway

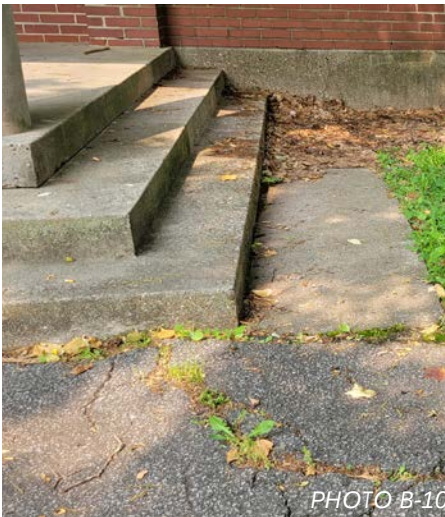
2. The right side of the steps have a similar condition to the left. Concrete is in fair condition with some gouges in the edges. Asphalt leading to the steps is cracked and uneven.

PHOTO B-10  
Front Steps, right side

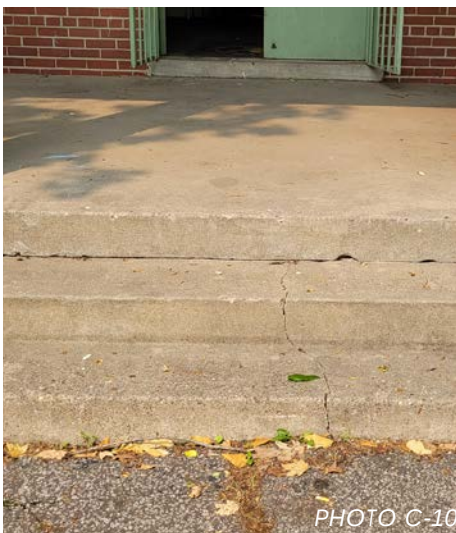
3. The center portion of the steps also shows signs of age and wear, with cracking and uneven chunks of concrete missing. Asphalt leading to the steps is cracking and uneven.

PHOTO C-10  
Front Steps, center

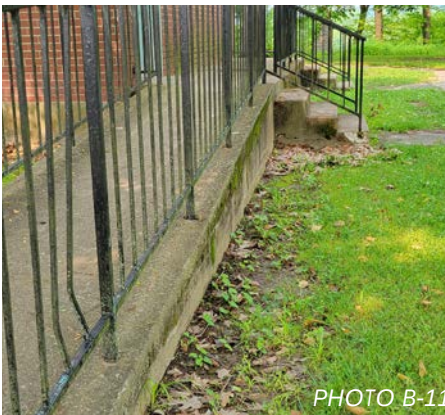
2. The sides of the ramp and steps are showing age and deterioration. The ramp appears to be in fair condition but one set of steps has a large piece of concrete broken off.

PHOTO B-11  
Back Walkway

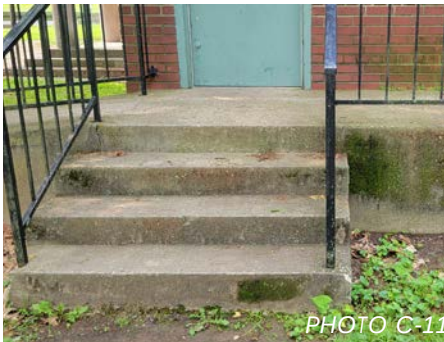
3. The steps are original to the 1952 building and are generally showing age with mis-coloration, stains, and cracking.

PHOTO C-11  
Missing Sections

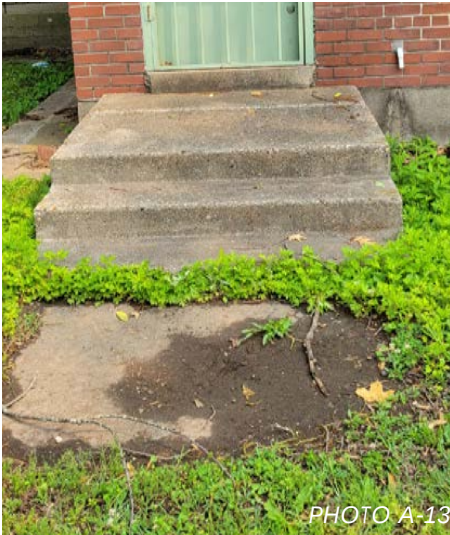
PHOTO A-13  
Storage room door

1. Access to both the storage room and kitchen is provided by an asphalt path and concrete steps. The concrete steps have some chips and rough edges, and have settled somewhat. The asphalt leading to the steps has large cracks and vegetation growing throughout.
2. Large sections of pavement are either missing or completely covered by soil and vegetation. This section of the path connects the front of the building to the maintenance areas as well as the parking lot.
3. An equipment pad is located outside the Kitchen door and is completely enclosed. The enclosure is rusting and likely needs replacement.

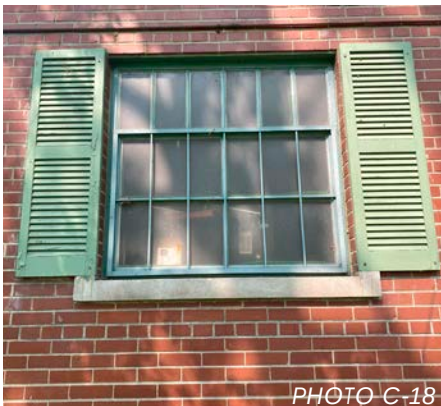
PHOTO C-18

The original windows were a painted steel sash with single pane glass. At the restrooms, obscure glass was indicated to be installed based on the original design drawings. The original mullion pattern for the primary windows was a 3 over 5 pattern. The left and right window sections were operable casements. The new replacement windows were installed in the 1988 renovation. They are a steel frame with 6 over 3 panel pattern. This windows currently have a plexi-glass panel that replaced the intended glass panes. The replacement of the glass and the new mullion pattern was selected to prevent/minimize break-ins. The smaller opening limits the ability of someone getting through the openings.

Typical Window with bars and Shutters

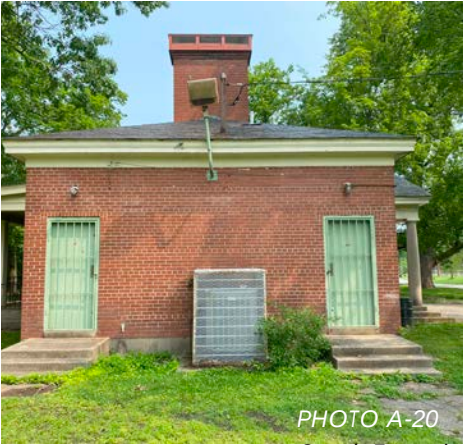
PHOTO A-20  
South Facade

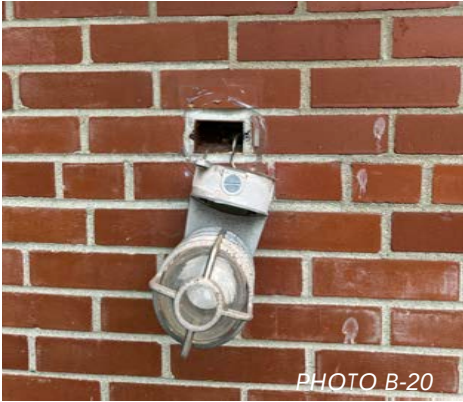
PHOTO B-20  
Security Light Fixture  
hanging off of the wall.

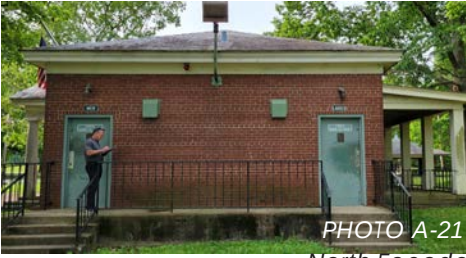
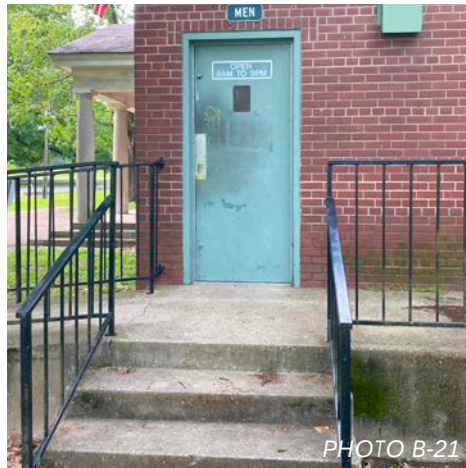
#### Exterior Observations (cont):

Photo of Men's Restroom Door, Steps and Railing.

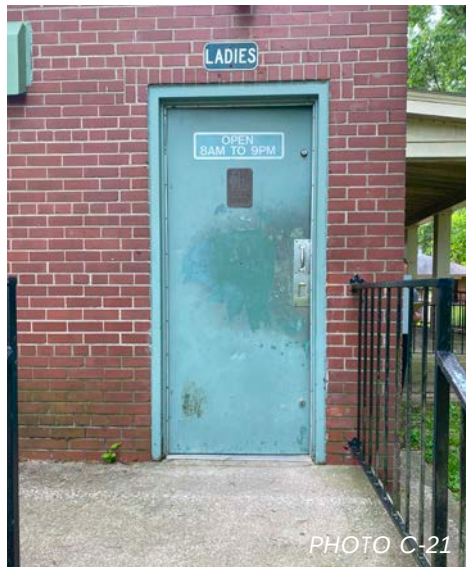
Photo of Women's Restroom Door, Steps and Railing.

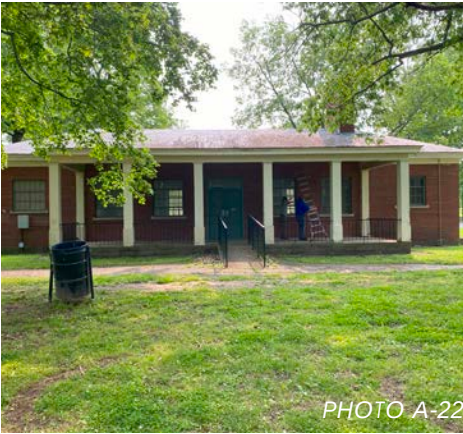
PHOTO A-22

West Facade

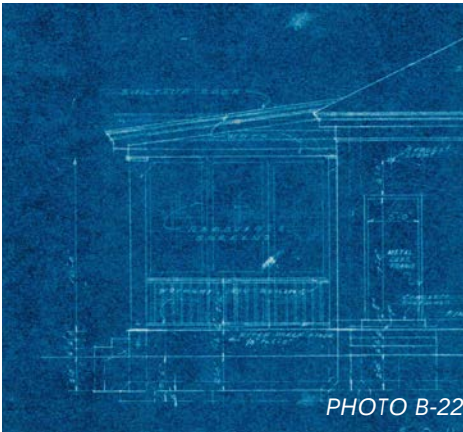
PHOTO B-22

Enlarged South Elevation  
of Porch

West Facade - The West face of the building is the facade that faces the Ohio River. Centered on this facade is a covered porch structure that is roughly 41' long x 12' deep. Supporting the porch roof is a series of equally spaced wooden columns. The porch floor which was set roughly 12" below the finish floor of the lodge. During the 1988 building renovation, a new concrete overlay floor was added so that the new porch floor would match the original main building floor elevation. In reviewing the 1988 renovation plans, it is unclear if the new concrete floor was physically tied or pinned to the original concrete floor.

The original porch design was constructed with wrought iron railings on three side of the porch with the exception of the center west bay. The spaces between the wood columns were infilled with a mesh insect screen. At some point in the building's life the original wrought iron railings and insect screens were removed. The railings that are installed currently are painted metal modern railings. These railings are showing various stages of rust and deterioration.

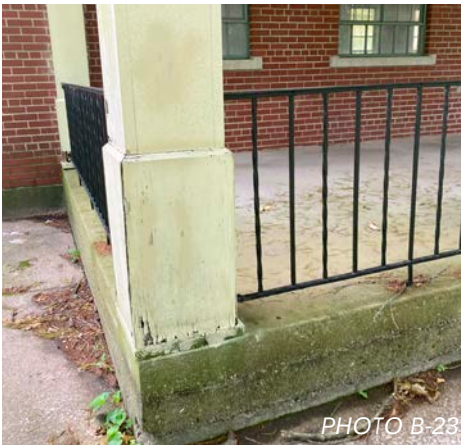
At the time of the 1988 renovation, the original wood roof supporting columns were removed and new hollow wood columns were constructed. In reviewing the new wood columns, most or all of these columns are showing various degrees of wood rot. This also includes the wood columns that are engaged with the exterior wall. Upon closer inspection of the construction of the wood columns, we discovered several details that were overlooked when the columns were built. When designing/constructing exterior wood columns, it is necessary to provide a vent space at the top and bottom of the columns. This vent allows for moist air that develops within the column to escape and ventilate. The columns were not constructed with these vents thus contributing to the degradation of the columns. Additionally, since these columns were originally constructed as hollow load bearing columns, the wood joints of the column shafts were built using lock-mitered corners. The columns that are in place currently in place were not constructed using the same method.

PHOTO B-23  
Photo of current wood columns and  
railings.

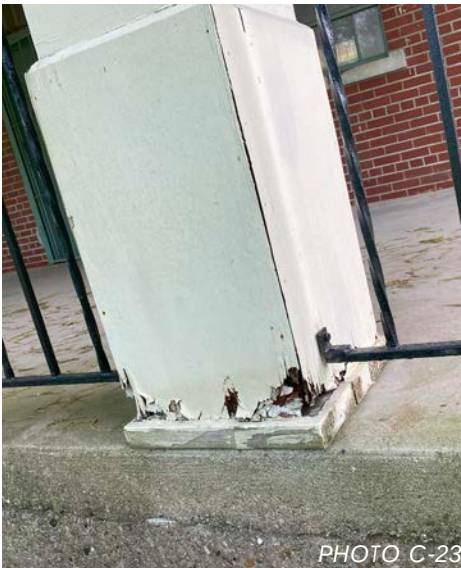
PHOTO C-23  
Detail photo of column base.

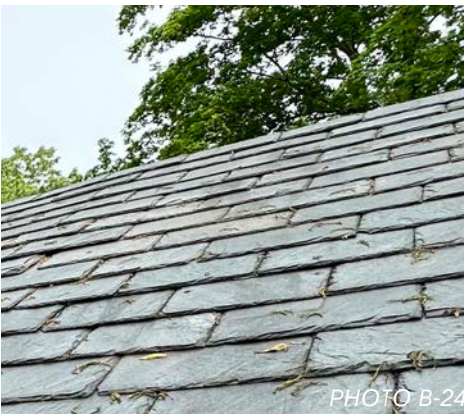
*Detail photo of current  
Slate Roof*

In reviewing the condition of the slate roof that is currently installed we noticed that on all sides of the roof there are multiple broken slate shingles. These locations range from ridge cap locations field locations, transition shingles and edge shingles. Based on the amount of broken or damaged shingles, our recommendation is going to be a complete replacement of the shingles and underlayment system. It should be noted that we were not able to determine the material used for the underlayment of the slate. Typically, this would be a rosin paper slip sheet.

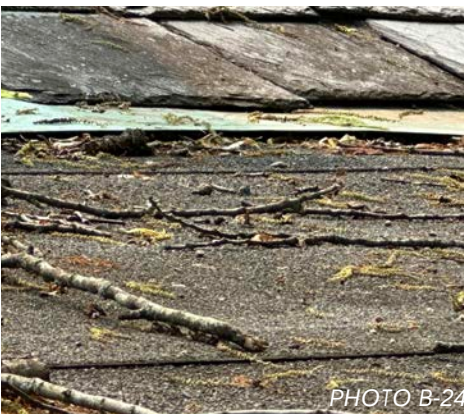
The South porch roof is constructed using low pitched 2" x 8" rafters spaced at 16" centers. The original sheathing was the same 1" x 6" Tongue & Grooved wood assembly as the main roof. At some point in the building's life, the 1' x 6" T & G decking was replaced with 1/2" or 9/16" plywood. At the time of our review, we could not determine if the plywood installed is exterior grade material. The roofing material indicated on the original drawings was a built-up roofing material. This is what is currently installed as well. The flashing currently installed is a lead coated copper flashing.

*Detail photo of built up  
roof at South porch*

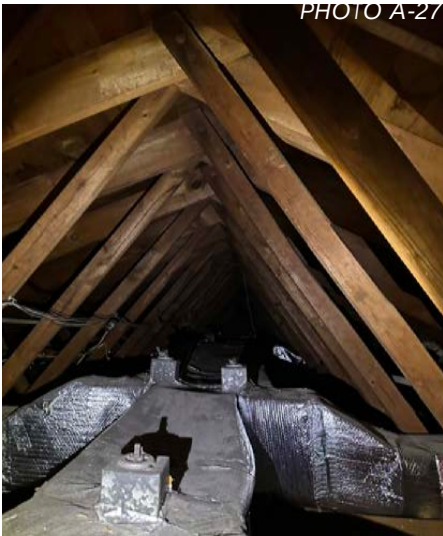
View into Attic

**Attic:** The attic is only accessible by a ladder through a hatch in the Community Room. All of the primary ducting runs through this area and feeds through the ceiling. There is more modern fiberglass insulation that appears to have moisture damage and is missing in various places. There are four ventilation pipes the extend from the attic to the exterior of the building.

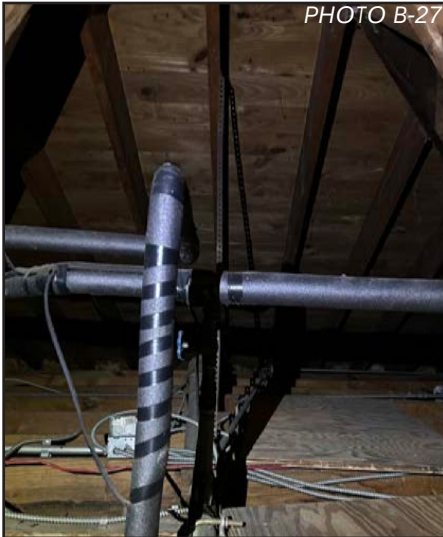
Ventilation Pipe in Attic

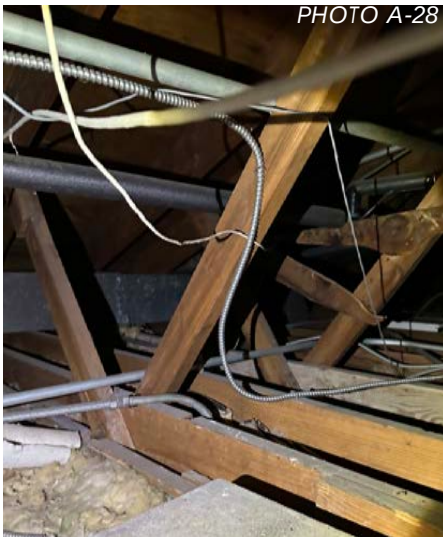
PHOTO A-28

Attic Space

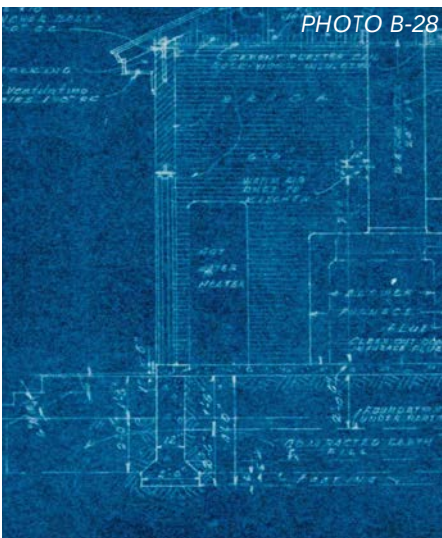
PHOTO B-28

At the exterior there is evidence of settling in various places at the foundation, but there is no evidence of any major structural issues.

Stem Wall and Slab Construction

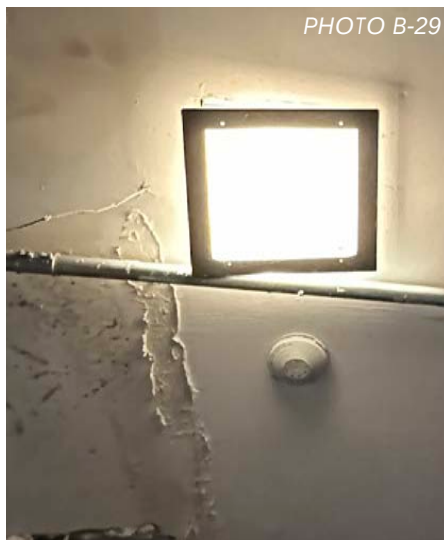
*Typical Fire Alarm*

- The security system/smoke detectors appear aged and should be tested to ensure operation and replaced if necessary.
- Assuming A-3 occupancy, a full fire alarm system is not required by code.

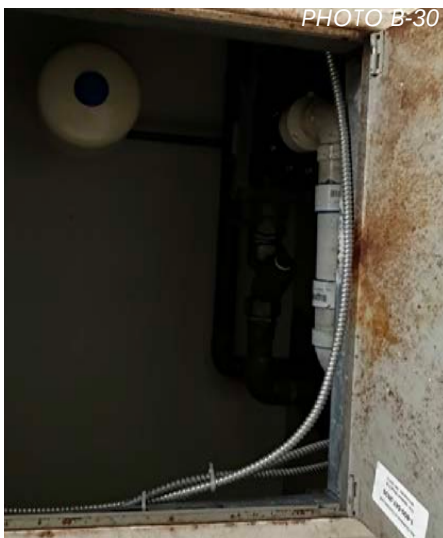
- The domestic water entrance couldn't be located. We observed water piping at an attic access hatch and in the utility room. Piping, where visible, was copper. Water piping in the attic had closed cell insulation, although there was some insulation that was removed/missing. It also appeared that there was heat trace under the water piping insulation, but this couldn't be verified.

View into Plumbing Hatch In Men's  
Room

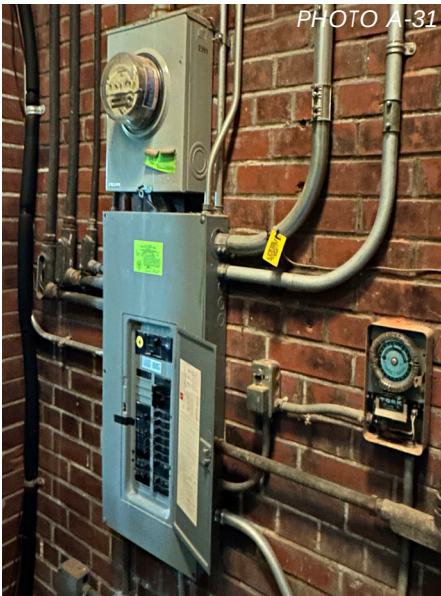
*Existing Electrical*

- The electrical panel was not labeled. The existing electrical circuits have been modified over the years and it appears several circuits are not being utilized. Several breakers were turned off.
- In general, the interior and exterior lighting is in disrepair and needs to be replaced. New light fixtures need to be selected and installed that would provide adequate light levels to all areas of the building. Specifically, externally under the patio areas, at the restroom entrances, and around the full exterior of the building.
- Adding battery powered emergency lighting should be considered.

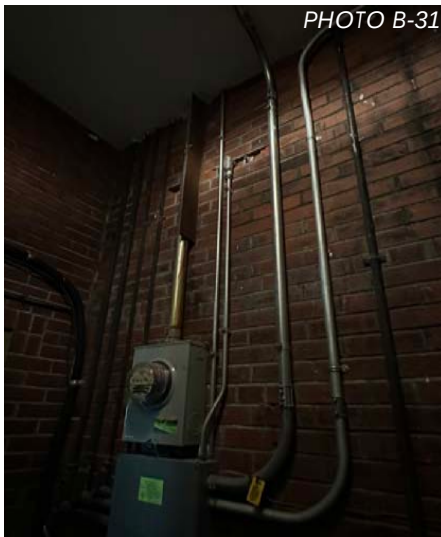
*Existing Electrical to Ceiling*

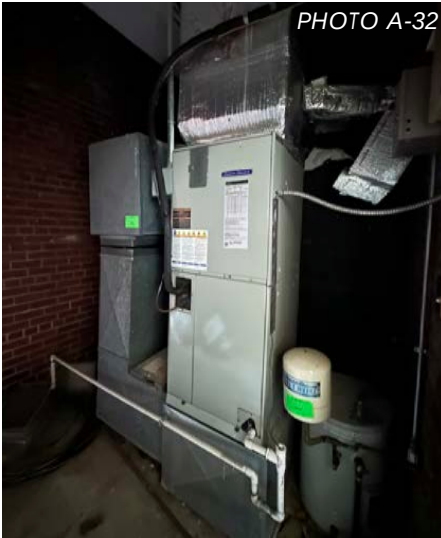
Existing HVAC System

- The building is served by a single Trane 5 Ton Split System Heat Pump.
- The existing heat pump system is approximately 14 years old and appears to be in fair condition, space temperatures were controlled while we visited the site.
- A Honeywell programmable thermostat is used to control the heat pump system.
- The outdoor heat pump is enclosed in a metal cage.
- HVAC system utilizes supply and return air duct work installed in the original 1951 construction.
- There are balancing dampers present at each supply duct takeoff.
- There are two 18" x 32" return grates, one on either side of the fireplace.
- There are side-wall bathroom exhaust fans for each restroom.

- The heat pump system is approaching the end of its useful life.
- Duct insulation is in disrepair, several sections of the duct have bare, exposed sheet metal.
- The supply grilles/diffusers in the meeting space as well as the restrooms are corroded and in disrepair.
- The restroom exhaust fans did not turn on, function could not be verified.
- The range did not have a hood.
- There is no OA being delivered into the building. Natural ventilation satisfies the OA requirement, but with the doors and windows closed and the exhaust fans in the restrooms running the building will operate in a negative pressure condition.

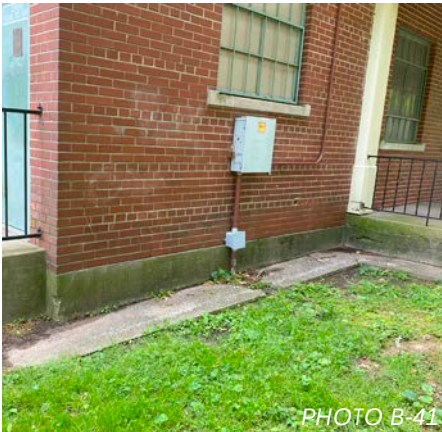
*Concrete Apron around Structure*
