# Master Plan for the Renewal and Management of **CHICKASAW PARK**

**Prepared for the City of Louisville, Kentucky  
David L. Armstrong, Mayor**

By the Louisville Olmsted Parks Conservancy, Inc.  
In conjunction with  
Metro Parks of Louisville & Jefferson County

**January 2001**

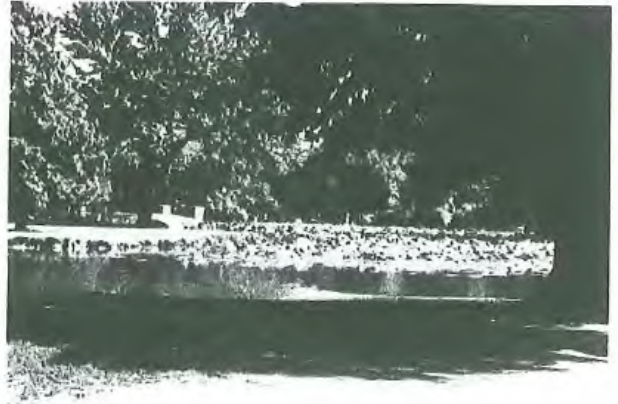
The pond itself is in somewhat poor condition with eroded banks from the overabundance of waterfowl, too much aquatic vegetation (water lotus) clogging the water, poor access, and poor drainage. The water quality in the pond has been suspect of toxic chemicals for several years after fish taken from the lake tested positive for certain types levels of dioxin. The City, after several years of testing, has determined that there is little risk to the public as long as people do not eat fish caught in the pond.

The water source for the pond is a 2-inch City water line located at the extreme north end of the pond. This line has no backflow prevention and no direct shut-off valve without turning off most of the other water supplies in the park. The drain for the pond is a 6-inch overflow pipe that connects to the storm drain along Southwestern Parkway. This line is insufficient for extreme flows and causes the pond to overflow toward Southwestern Parkway, flooding a broad swath of park as well as a significant length of the walking path.

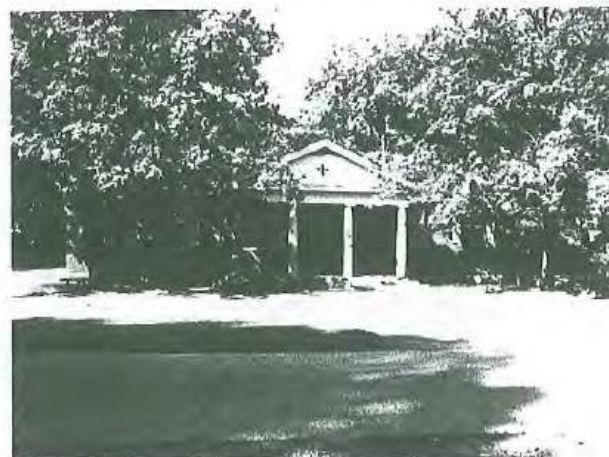
The lodge building is in poor condition and is too small for the large family reunions that occur here. The building can currently hold only 50 people under its shelter. The bathrooms are in need of plumbing repairs and the kitchen is inadequate for the intended use. The interior space of the lodge, although small, has a nice fireplace but very poor acoustics. The heating, air conditioning, electrical systems, and lighting are also in need of repair and improvement.

The basketball court is in a good location but may need resurfacing within a few years. The old bandstand, which was cut off from its audience by the floodwall, is quickly deteriorating and unsafe.

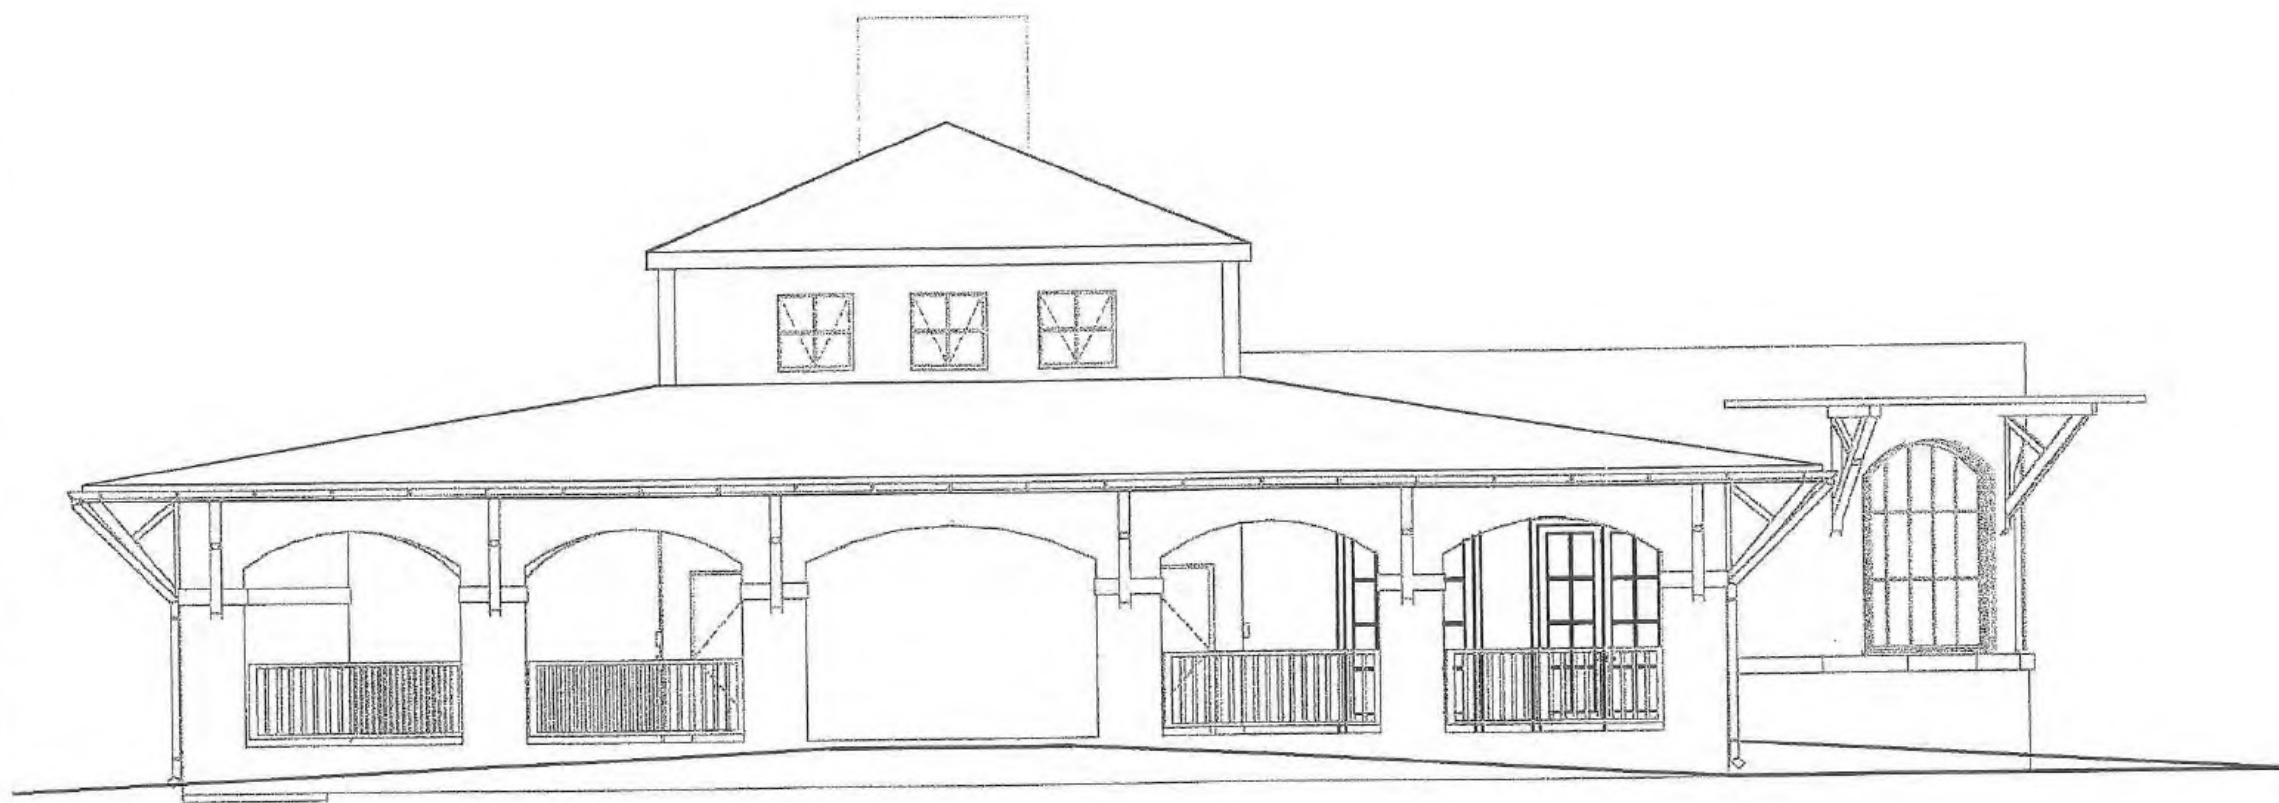
Chickasaw Park Lodge  
North Elevation 1/8" = 1'-0"
